Using Ishikawa Method in Power Hacksaw Maintenance

Abstract:- Mechanical manufacturing companies engaged in mass production cannot do without the cutting of raw materials for the assembly of new machines. The overall objective of this research endeavor was to identify and subsequently correct of the underlying factors responsible for the malfunction of a power hacksaw machine that had been left unused at LAHMOTECH for several years, using the Ishikawa method. Within the framework of the research, sequences of steps were taken to in order to successfully and permanently address the problem. An initial diagnosis was performed, followed by the implementation of the Ishikawa method to identify the root causes of the failures. A corrective action plan was then developed. As a result of the methods performed, some of the root causes identified were operator neglect of maintenance, the absence of the cooling system, exposure of the motor, etc. Corrective actions implemented included replacing the blade, adaptation of a lubricating system, and cleaning of the motor, etc. The Ishikawa diagram provided the advantage of a correct orientation to correct the non-conformities. The performance r

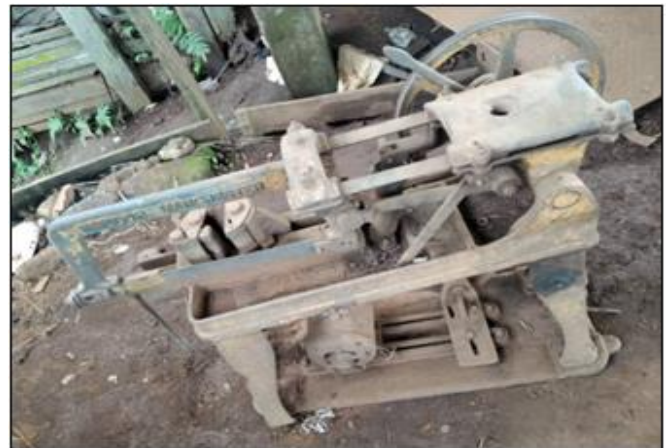
Located in Bamenda, Cameroon LAHMOTECH is a fabrication company specializing in the maintenance and fabrication of agricultural machinery, woodworking equipment and the repair of heavy-duty vehicles. The company primarily uses handheld hacksaws for cutting operations, while angle grinders are used for thicker materials. While these tools are adequate work for most fabrication tasks, there is still room for improvement in terms of efficiency and productivity. While the hacksaw is easy to use, it has limitations when cutting large thicknesses and prolonged use of the hacksaw can lead to musculoskeletal disorders that reduce worker efficiency. Angle grinders, on the other hand, are suitable for cutting thicker materials, but they pose safety risks and are dependent on the operator for cutting accuracy. Inconsistent accuracy often results in material waste and longer production times, which affects customer satisfaction. Due to the limitations of the portable hacksaw and the angle grinder for mass production, the company decided to refurbish a retired power hacksaw (figure 1).

Fig 1 Retired Power Hacksaw at LAHMOTECH

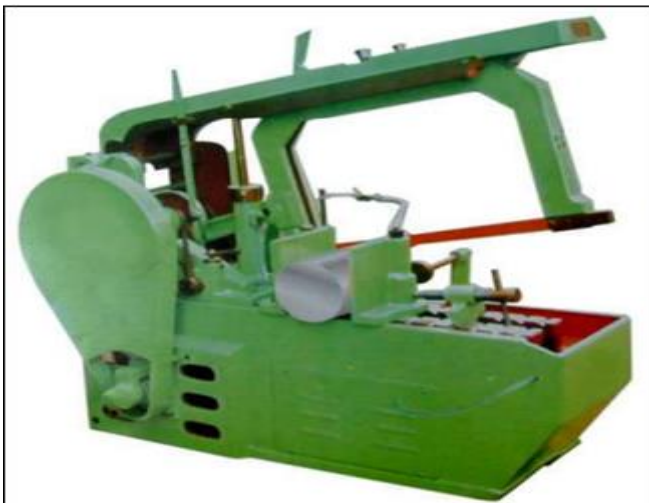
Fig 2 Hacksaw Machine [8]

The power hacksaw shown in figure 2 is a machine used to cut across materials such as aluminum, brass, and mild steel. There are many electrically operated power hacksaws [7, 8] from different companies with different specifications available for shop floor use, such as utility, heavy duty, and high production models. Power hacksaws are widely used in operations that require cutting of large dimensional materials such as metals, wood, plastics, glass, etc. and they have been designed to perform the difficult and time consuming work in minimum time, but they have one and major disadvantage that those are able to cut one piece of bar at a time [4].

Compared to the bandsaw, the power hacksaw is slower because it cuts into the material in a forward and backward stroke, with the cut occurring only during the backward stroke. A horizontal bandsaw, on the other hand, works continuously without wasting a stroke. There is no question that the bandsaw is far more effective than the power hacksaw in terms of efficiency.

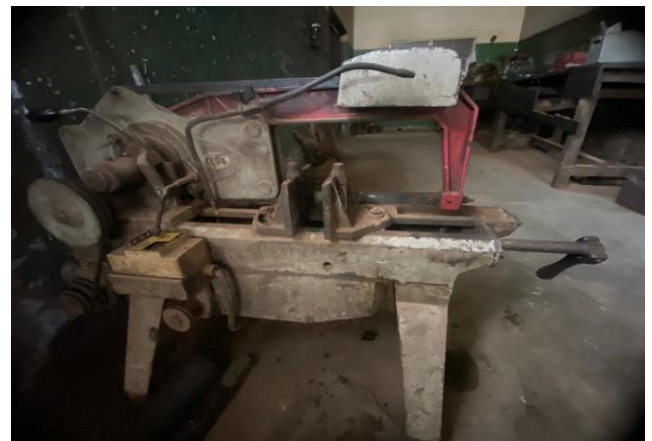
Fig 3 Horizontal Bandsaw Machine

A band saw (figure 3) is a power saw with a long, sharp blade that consists of a continuous band of toothed metal stretched between two or more wheels to cut material. They are primarily used in woodworking, metalworking, and lumbering, but can cut a wide variety of materials [9]. In recent years, the power band saw has become very important in machine shop operations.

Circular saw blades are thicker and stiffer than band saw blades. This reduces vibration, which can dramatically reduce the efficiency and life of the blade and increase the overall cost per cut. While band saws are less expensive, circular saws offer higher productivity. The main disadvantage of the band saw is that it is more dangerous than other power saws such as the jigsaw or reciprocating saw.

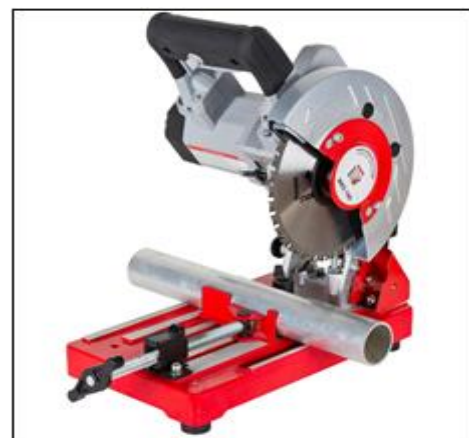
Fig 4 Horizontal Circular Saw

The circular saw (figure 4), also known as a cold saw machine, is a power saw that uses a toothed or abrasive disk or blade to cut various materials using a rotary motion that rotates around an arbor. A metal cutting circular saw machine is designed to shear various metals at high speed with the toothed cold blade, allowing both the saw blade and the raw materials being cut to remain cool during the operation [10]. To achieve this, the saw blade transfers the heat generated to the metal chips formed during the high-speed metal cutting process. In the high-speed cold sawing process, the metal materials are released by the blade teeth in the cutting motion as the feed system rotates the saw forward toward the work pieces.

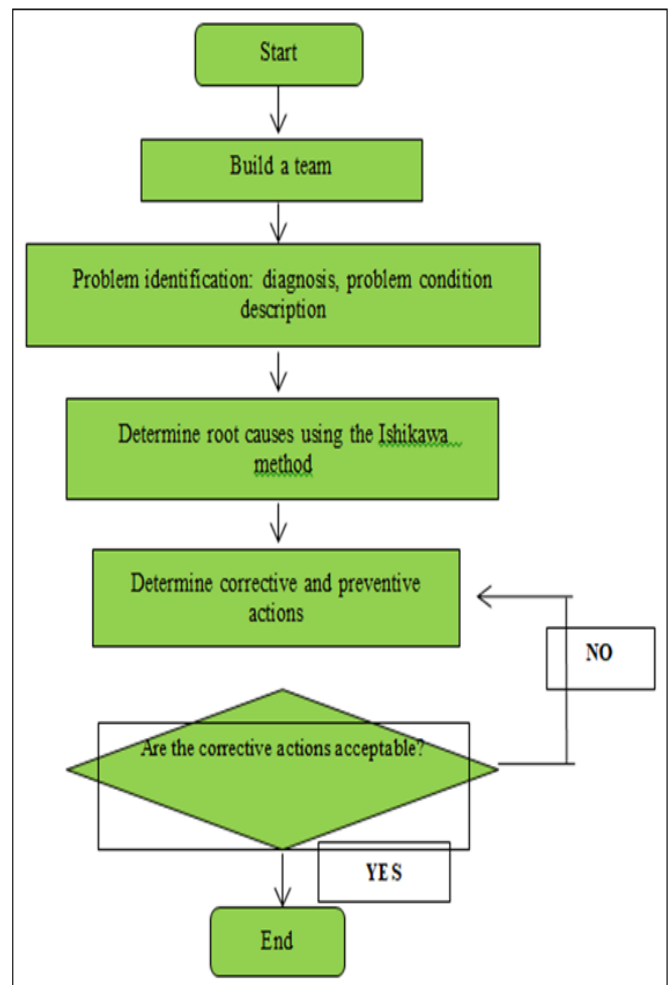
The root cause corrective action process is a valuable tool for maintenance professionals who want to address and prevent problems in a structured and systematic way. The flowchart in figure 5 has been developed and is used throughout the root cause corrective action process.

Fig 5 Methodology by Steps for Root Cause Analysis and Corrective Action

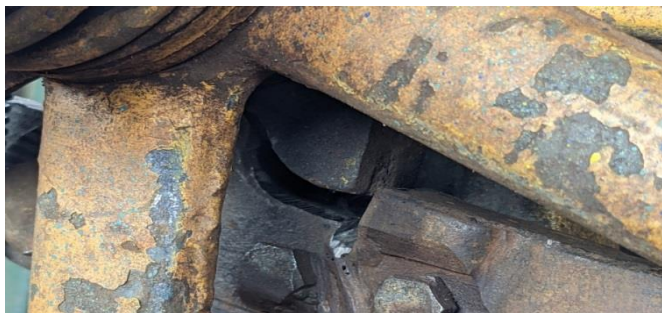
The engagement system consists of the dog clutch, clutch lever, and release lever. As shown in figure 6, there was a gap between the release lever and the clutch lever, and this gap made it impossible for the clutch lever to engage. It was also noted that the release lever had been repaired because it was broken. Since the machine could not be engaged for cutting, it could not be disengaged automatically.

Fig 6 Picture of the Clutch Lever and Trip Lever before Corrective Action

The release lever was found to be defective because there was a gap between it and the clutch lever, making it impossible to engage and disengage. This handicapped the machine as the cam and follower would not transfer motion to the blade. The blade was identified as another critical component; the teeth were worn, making it very inefficient in cutting material and also affecting the quality of the finished product. The motor was found to have so many iron fillings that it would not start, leaving no power source for the machine to function.

More material was added on the trip lever by welding it with steel electrodes and then it was shaped using a grinding disc such that the clutch lever could hook into it (figure 16). The trip lever was filled but at some point, the clutch lever kept on sliding off and disengaging and so we used the pin on the trip lever to hold the clutch lever in place and as such the system does not automatically disengages.

Corrective action was taken and the legs of the stand were properly positioned and we experienced less vibration. The trigger lever was filled, but we still experienced slippage during cutting. To overcome this problem, the trigger lever was moved to the engagement position and we use a switch to turn the power on and off. The cooling system was installed by adapting a new pipe that provides a flow rate of

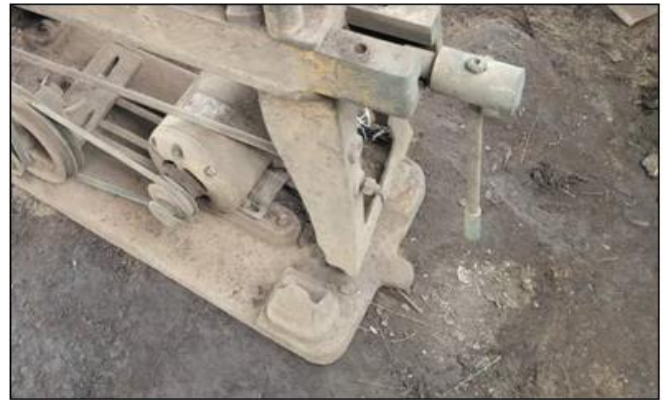
A pair of legs on the power hacksaw stand were broken and out of position as shown in figure 8 below. There were several cracks in the stand. The paint was peeling and dirt and rust had accumulated on the stand.

Fig 8 Picture of Broken Legs of the Power Hacksaw Stand

The diagnostics that were performed revealed faulty components of the machine. Some legs of the stand were broken and as a result the power hacksaw was no longer in a balanced position and cutting could not be performed due to the intense vibrations, which could lead to further cracks in the frame. The absence of the cooling system, which is a very critical part of the power hacksaw, meant that the blade of the power hacksaw would be damaged prematurely. Another component that failed was the dog clutch. The dog clutch consists of the clutch lever, the release lever and the shafts.

To repair the broken legs of the stand (figure 14), we realigned the legs to their right position using a G-clamp and secured them in place. One leg was secured with supports of mild steel sheets. The sheet was cut according to the area which needed support and bolted to the leg and welded such that it remains in position. The other leg was secured by simply welding it with steel electrodes.

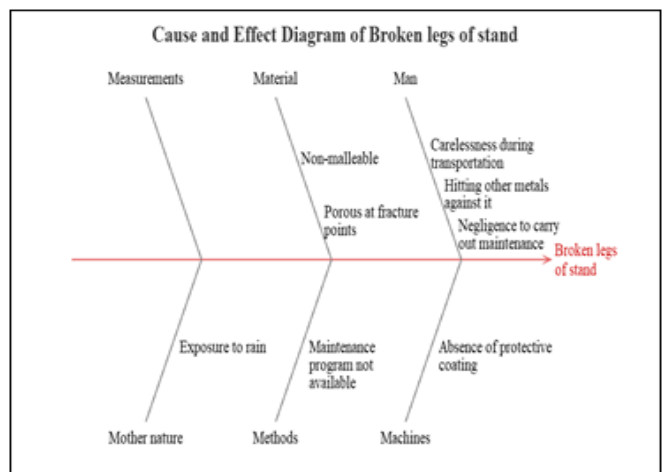
From the cause and effect diagram of the broken stand shown in figure 9, we can see how each category contributed to the failure of the stand. The main causes are the non-malleable material used for the stand and the workers' carelessness with the machine; the machine was exposed to adverse weather conditions.

Fig 9 Cause and Effect Diagram of the Broken Stand

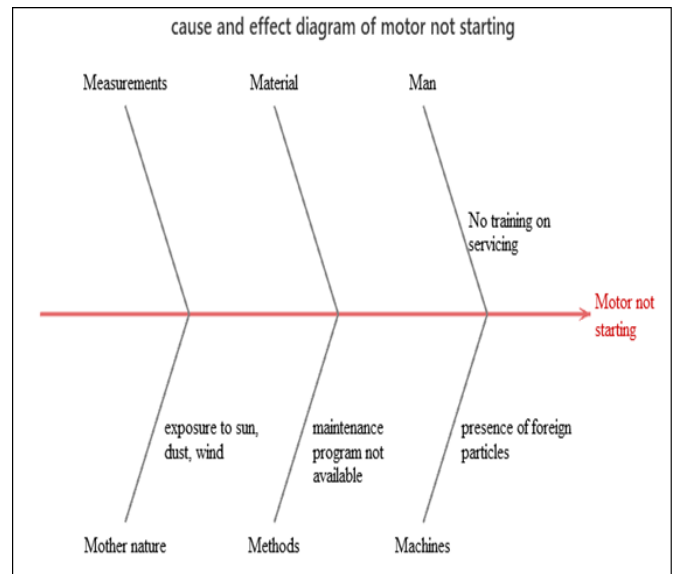
From figure 12 of the Failure to start cause and effect diagram, the causes of this problem can be identified as not maintaining the engine and exposing it to adverse weather conditions with the presence of foreign particles.

Fig 12 Cause and Effect Diagram of the Motor Failure

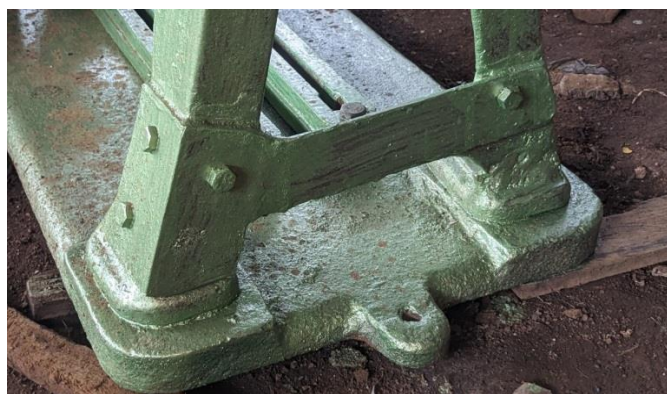
Fig 14 Broken Leg after Corrective Maintenance

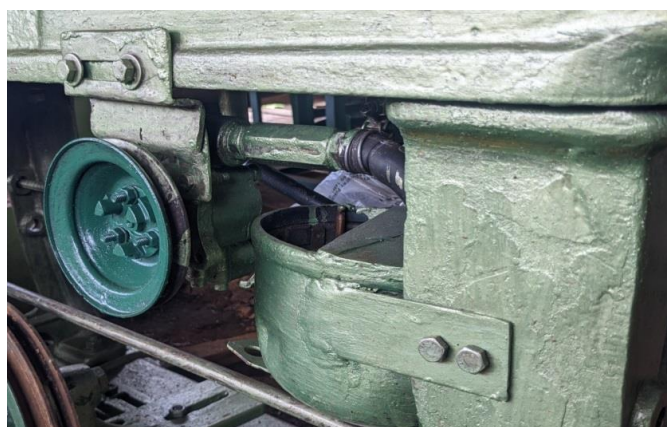
Fig 15 Pump and Tank of the Cooling System

The exact model of the pump could not be found, so we adapted a pump to the engine pulley and connected the water hoses to a tank (figure 15). The tank was made from the gas tank of a refrigerator. In case of lack of coolant, inadequate cooling, wrong coolant or wrong coolant supply, the heat generated during cutting may increase the blade temperature, reduce its mechanical strength and thus cause plastic deformation in the shear zone of the cutting blade and possible failures such as blade braking, curvilinear cutting, tooth braking, blunt effect etc. [14].

1.1 gpm, which flows like an average kitchen faucet and will ensure that the blade is cooled quickly to preserve its life.

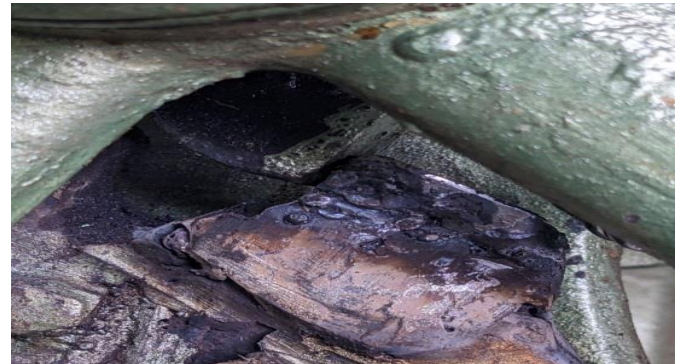
Fig 16 Trip Lever and Clutch Lever During Corrective Maintenance

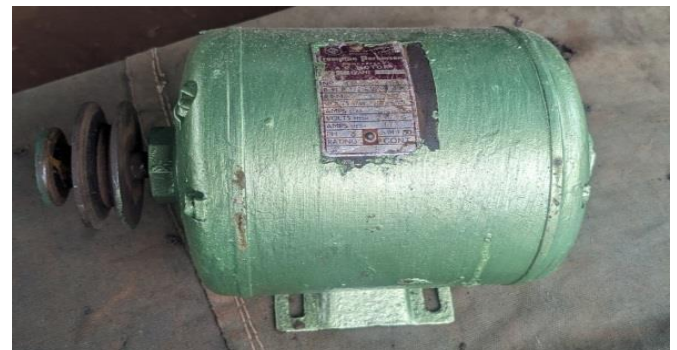
Fig 17 Motor after Corrective Maintenance

The inside of the motor was thoroughly cleaned (figure 17). It was sufficient to power the machine.

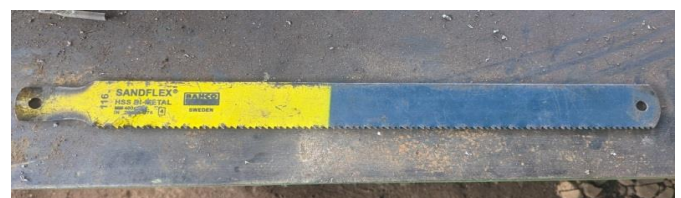
Fig 18 Brand New Saw Blade

A new A Bahco sandflex HSS bi-metal saw blade (figure 18) was purchased and installed on the machine. The blade was selected based on the thickness of the material to be cut with special attention to the blade shape, tooth spacing and clearance [15, 16]. There are four types of blades based on the materials, namely high carbon steel, alloy steel, bimetallic strip and high speed steel blades. Among these four, the most suitable for cutting hard materials such as mild steel bar and aluminum is a bimetallic blade based on the material properties, wear resistance and cutting performance [7].

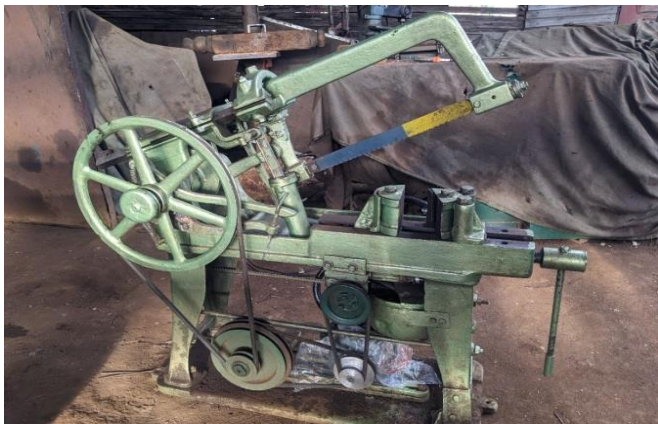
Fig 19 Power Hacksaw after Implementing Corrective Actions

After the corrective maintenance was carried out, the performance of the repaired machine was tested using the principle of six major losses (figure 19). This experiment was carried out for six days, and the shift period was taken as the period of cutting 5 square steel bars. Table 1 below shows the activities carried out each day and the losses recorded within the day.
