Enhancing Functionality and Minimizing Damage of Air Valves in Pipelines Using FRP Sheets

Abstract:- Pipelines play a vital role in ensuring the efficient and secure transportation of water, making their performance to keep the water continuously going vital. This research explores the influence of air valves on the localized damage and overall functionality of the pipelines. Air valves are critical components that help stabilize pressure and prevent vacuum formation. However, their installation can introduce structural weaknesses in localized areas. The study employs FEM modeling alongside field data from a collapsed bridge to assess the performance and damage in the vicinity of air valves. The findings reveal that strategic redesigns, such as optimizing air valve placement and reinforcing surrounding areas, can significantly enhance performance while mitigating local damage. Additionally, the research highlights the effectiveness of repair methods in increasing pipeline resistance to bending stresses and compares various repair and design approaches, providing new insights into mitigating structural damage in aqueduct bridges. This study addresses a critical gap in the literatur

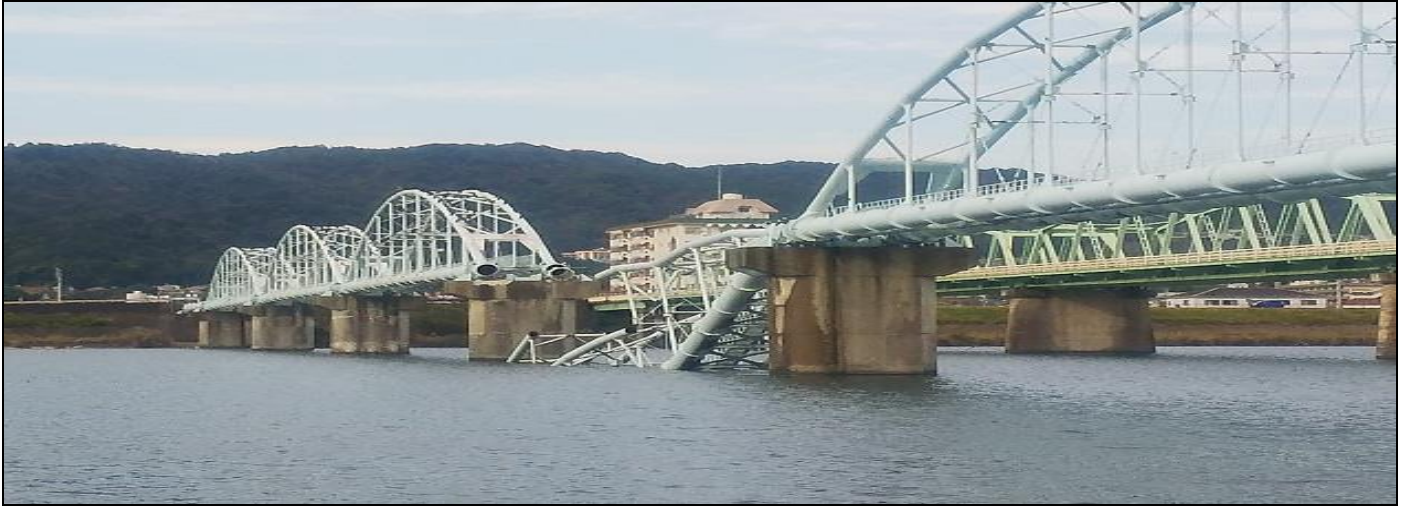
Fig 1 Wakayama Aqueduct Bridge Failure

On October 3, 2021, a partial collapse of the Musota aqueduct bridge over the Ki-nokawa River in Wakayama City occurred as a serious structural event. It was discovered that the reason for the collapse had to do with setting a retrofit member on the hanging member to avoid wind damage. However, when dust, water, and guano built up on the member, it created corrosion that deteriorated the hanging member enough to break. It has also been pointed out that the precise location of the fracture in the hanging member was not ascertainable during the inspection from the control walkway between the pipelines of the aqueduct bridge. It was because the fracture fell into a blind region above the retrofitted members.

This has resulted in severe structural damage and disruption of water supply services. The bridge in Wakayama had fitted a number of air valves, which were supposed to regulate pressure surges and prevent the development of vacuum conditions within the water-carrying pipeline. Initial investigations had suggested the local damage at one of these air valves as one of the causative factors leading to collapse. Figure 1 and 2 shows the damaged pipe after the incident.

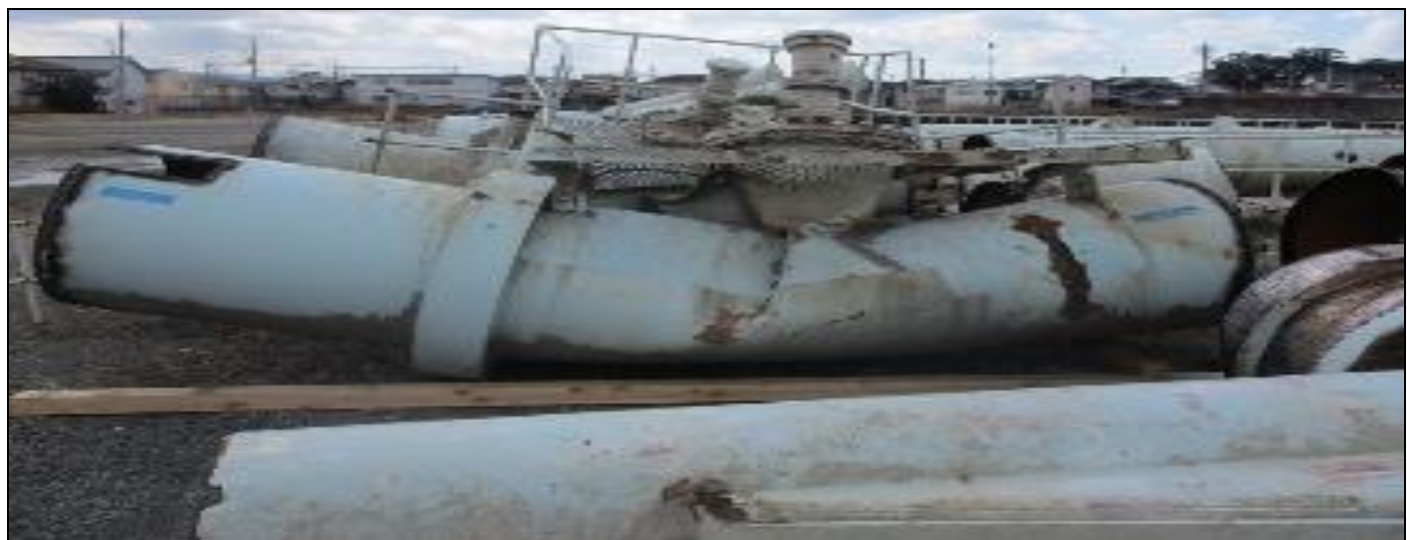
Fig 5 Damaged Air Valve Located in the Middle of the Span

The composite layer was incorporated by utilizing the composite layup feature in Abaqus, and applied to the C3D8R solid element to enhance the model's structural integrity. Boundary conditions were established by defining reference points at both ends of the pipe, aligned along the longitudinal axis. These reference nodes were constrained in all directions of translation and rotation, except for the longitudinal translation and the rotational degree of freedom, which were adjusted to account for the applied gravity force. Upon reviewing the deformation results, it is evident that the shape closely resembles the collapse pattern captured in Figure 5, a fixed-point camera image showing the failure of the aqueduct.
